# MONUMENT RECORD

P-13

STATE OF INDIANA - COUNTY OF MONROE

Section Fifteen (15), Township 10 North, Range 1 West

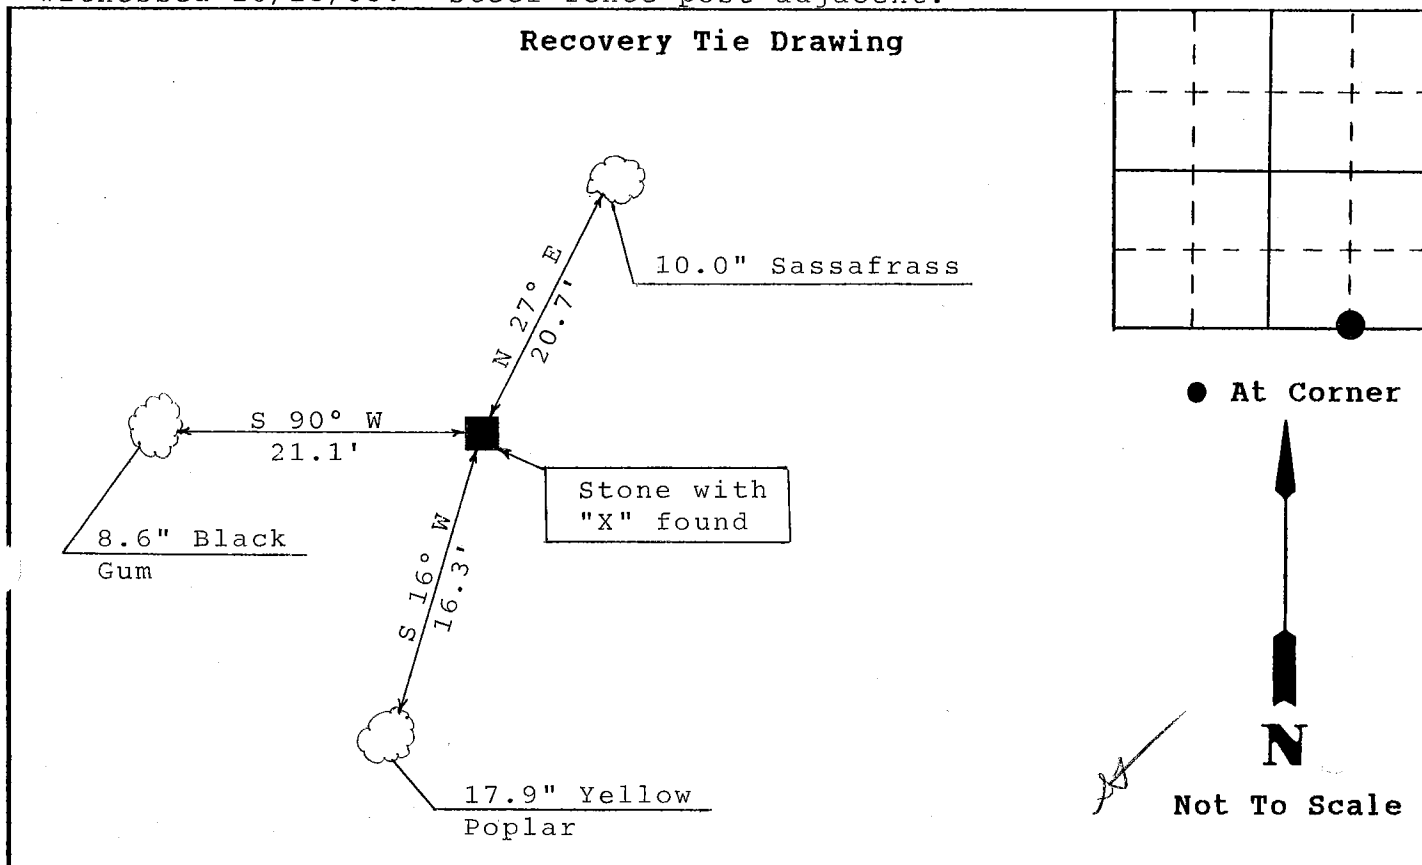
Recovery Tie Drawing

Monument Description & Remarks: Found Stone at SE Corner of W 1/2 of SE 1/4.

Stone was 4.5" X 6.5" X 7" out of ground, marked with "X". Corner

witnessed 10/18/85. Steel fence post adjacent.
